Village of Harrison, Wisconsin
Facilities Evaluation and Concept Planning
January 31, 2024

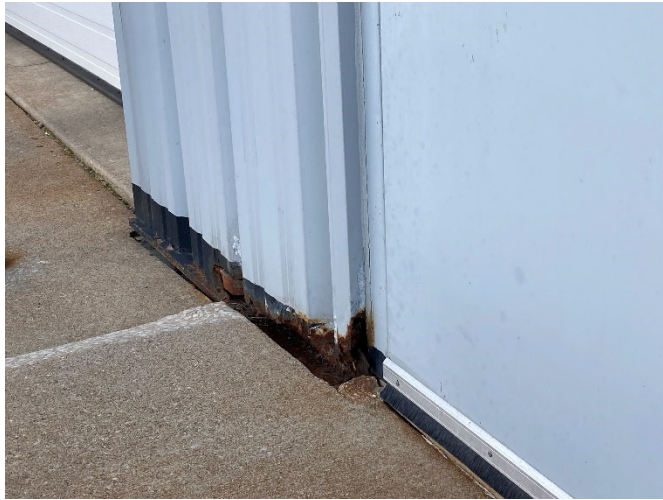
There was some visible corrosion to the metal wall panels at the overhead and passage door locations of the water department garage. Staff reported that salting operations prematurely eroded the paint finish on the metal panels and was causing corrosion. Some of the flaking corrosion was removed and asphaltic coating was applied to the panel to retard the corrosion process.

remove the corrosion that is deteriorating the metal wall panels.

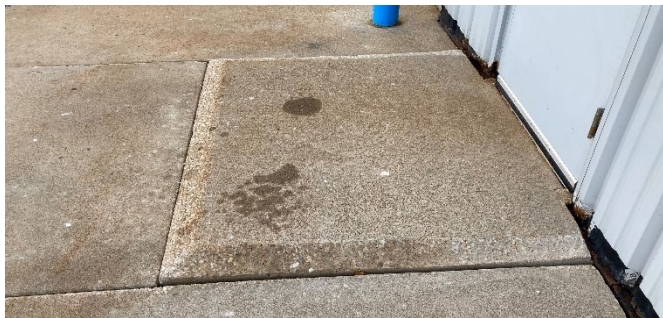
There was noticeable frost heaving of the approach slabs at the entrance doors. Over time, portions of the concrete was ground down to provide better accessibility to the entrances and eliminate trip hazards around the building.

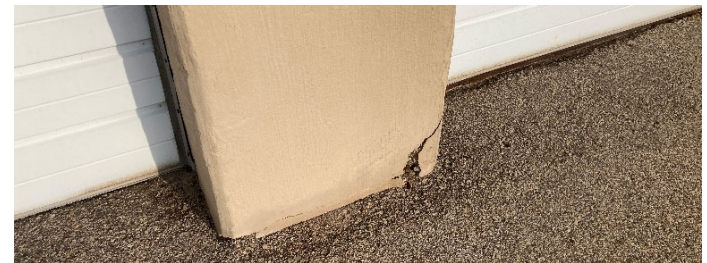
The exterior of Station 60 is in fair condition with the exception of some deteriorating masonry between the overhead truck Bay doors. Concrete masonry was used on most of the surfaces exposed to maintenance and potential abuse. Metal wall panels are installed 4 foot above grade on the north and West elevations of the building. The decorative concrete block is in fair to good condition and only require some surface staining removal.

Clean the stained exterior masonry, properly seal the surface of the exposed split faced block

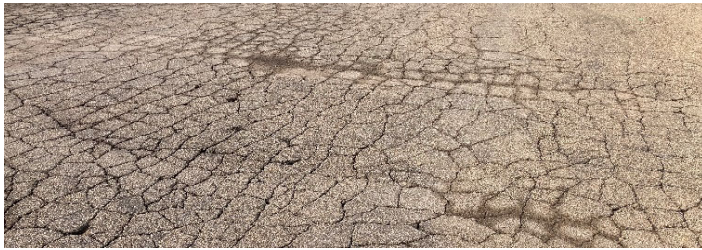
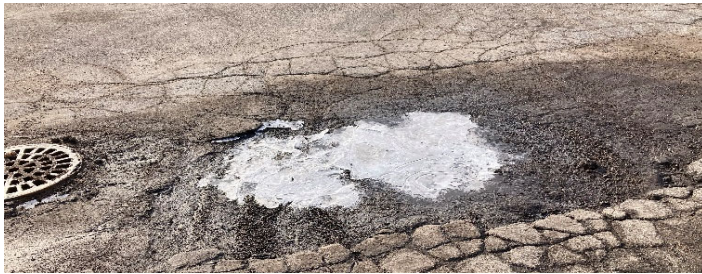
All of the asphalt pavement surfaces around Station 60 are in need of complete replacement. Signs of alligator cracking and complete absence of asphalt pavement are present in many of the areas of the parking lot.

Complete replacement of the asphalt paving on the site is a short-term recommendation. The current pavement is beyond its service life and is impacting stormwater drainage flow and does not provide a stable surface for training, maneuvering, and testing fire equipment.

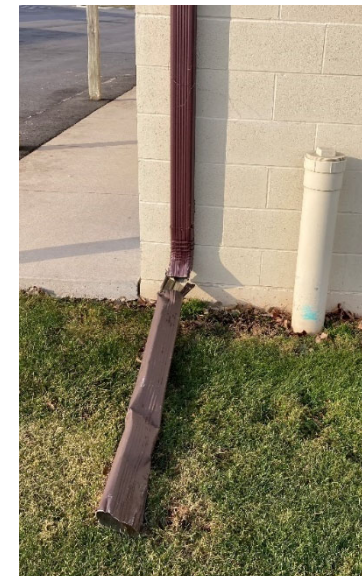
The condition of the restroom is in good condition with the exception of one of the urinals in the men's toilet room that sustained some damage due to vandalism. There are vented aluminum soffits, gutters and downspouts all of which appear to be in good shape. The downspout extensions have sustained some damage and should be replaced.

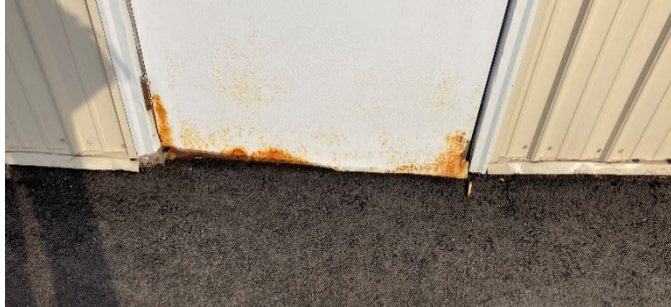
There are hollow metal doors that provide access into the concession kitchen and covered pavilion. The hollow metal doors are in poor shape and corrosion and delamination are visible on the door surfaces.

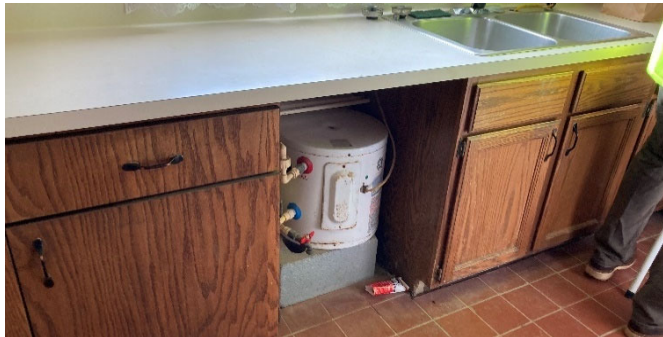
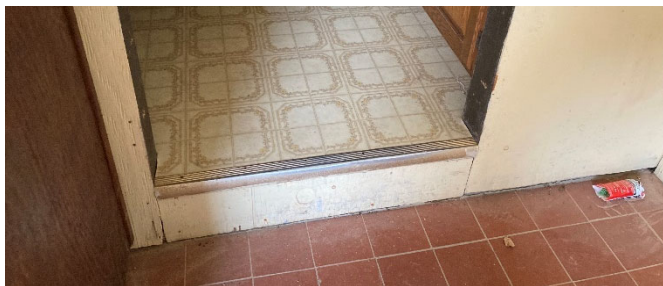
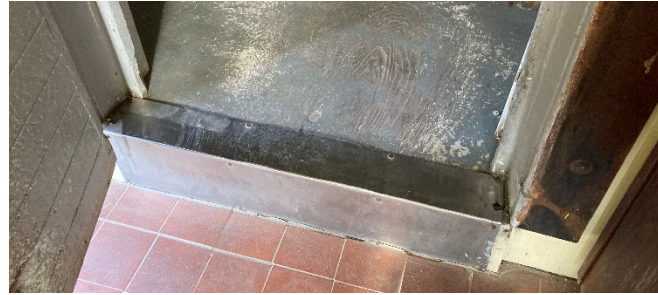
The interior of the concession kitchen show signs of wear. None of the serving counters are ADA height and sink is not ADA accessible. There is a step up into the serving area and walk-in cooler which is also not ADA accessible.

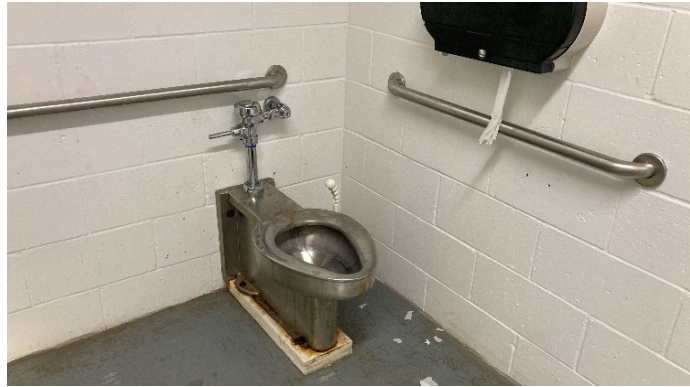
Both the men's and women's toilet rooms contain stainless steel toilet and lavatory fixtures set at the appropriate height and clearance distances to meet ADA requirements. There is a requirement to have an 18 inch high vertical grab bar above and perpendicular to the 36 inch grab bar on the wall opposite the water closet. It was noted that this vertical grab bar is missing from both the men's and women's toilet room and should be installed. The toilet paper dispenser is not mounted at the appropriate ADA mounting height and clearance requirements adjacent to the water closet. The toilet fixtures appear to have been shimmed up or leveled using resinous wood blocking which raises the rim height of the toilet above the required seat height for ADA accessibility. The resinous blocking material resist moisture penetration but it is not an

ideal material for shimming the toilet fixture on the concrete floor.

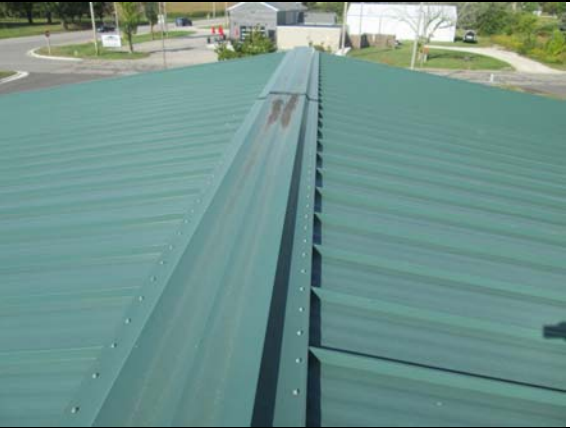
<p>1. Deteriorating sealant at penetrations</p>	<p>2. Standing water on ridge cap, laps sealed with EPDM</p>

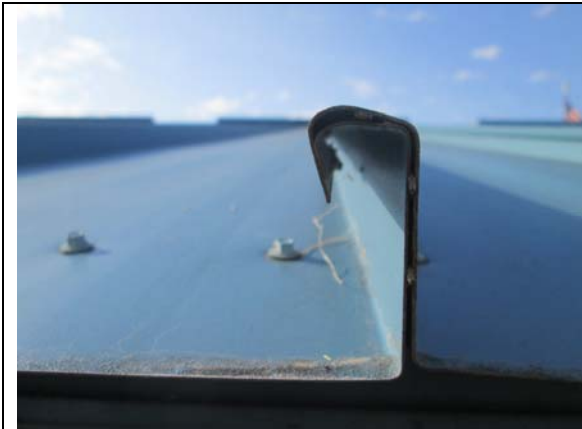
3. Poor seaming of panels

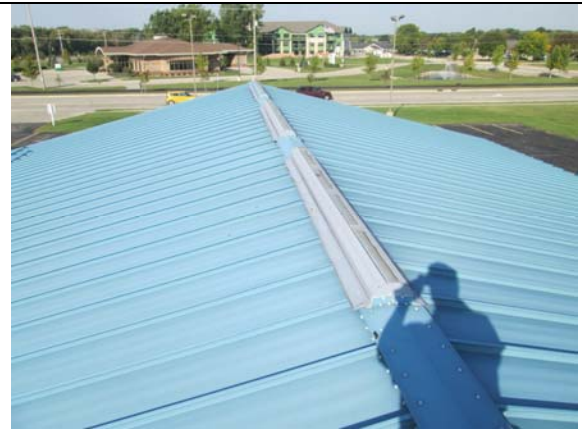
4. Vented ridge exhaust locations

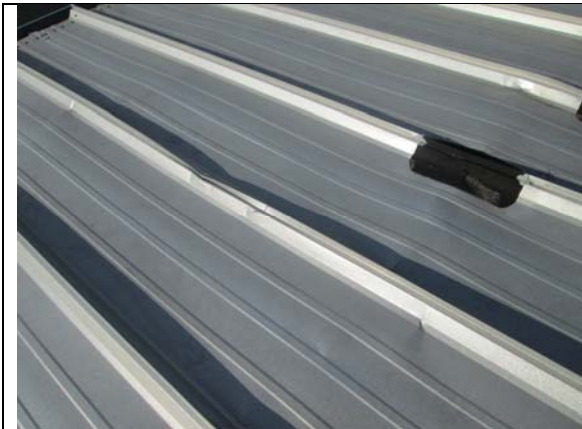
5. Typical panel damage

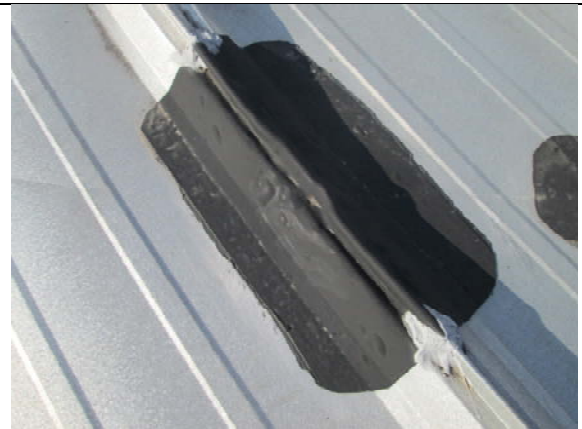
6. Panel repairs made with uncured EPDM and sealant
