Village of Harrison, Wisconsin
Facilities Evaluation and Concept Planning
January 31, 2024

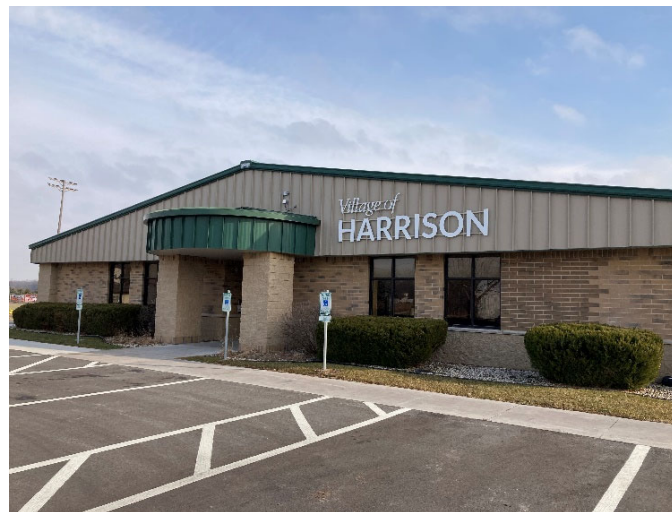
The parking lot contains concrete curbs and gutter around the South and West side of the building. Other areas of asphalt pavement are shouldered where they abut manicured lawn areas. Sheet drainage by sloping of the asphalt conveys stormwater away from the building. The asphalt parking lots have been recently re-paved and are in good condition.

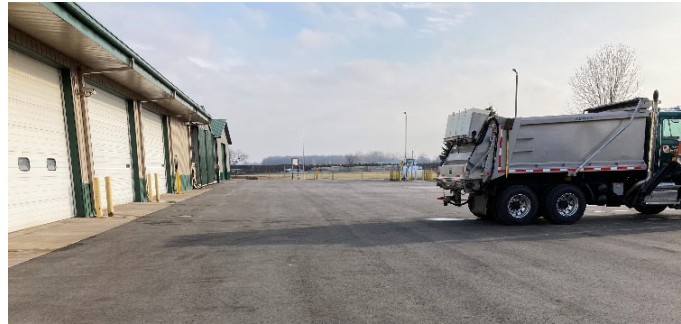
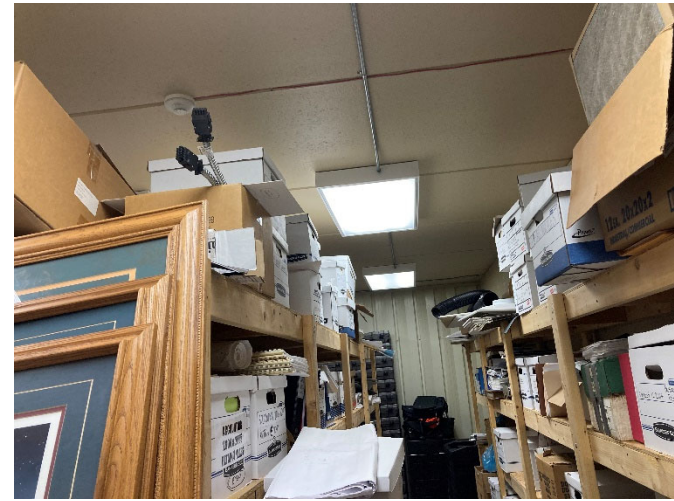
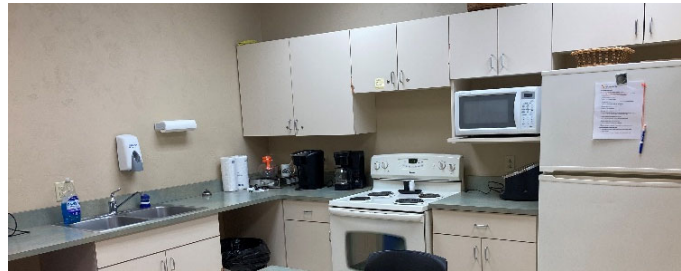
The interior of the building is in good condition and requires very little maintenance. The staff kitchenette and break area lacks ADA accessible countertop heights and there is not a compliant work surface directly adjacent to the residential oven/stove. All of the case goods and cabinetry are in good condition. The microwave shelf above the stove top is not ADA accessible.

Office and storage areas appear to be grossly under sized for the operation. In conversations, staff revealed the need for additional storage areas. The toilet rooms are ADA accessible and only lack the 18 inch vertical grab bar required on the side of the water closet.

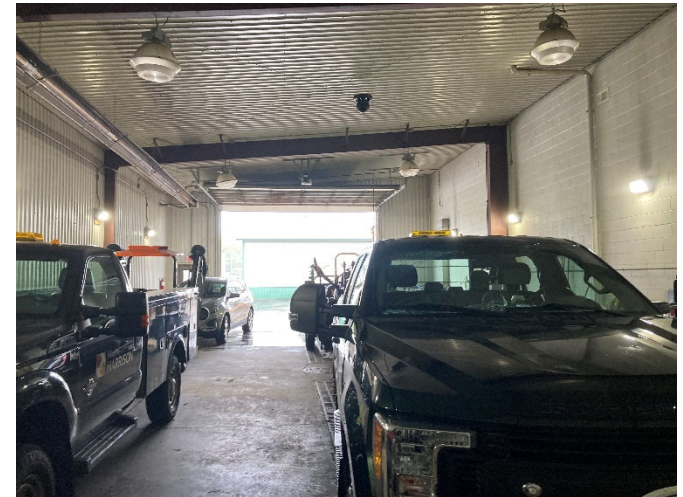
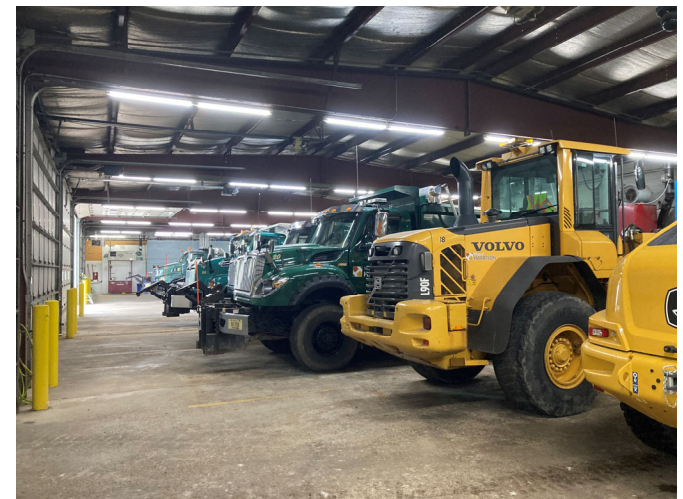
The DPW garage houses maintenance and Fleet vehicles. There is also a small maintenance shop operation that shares space with the vehicle storage areas within the DPW garage. The proximity of this maintenance shop is not ideal from a safety perspective. The shop operation shares space with vehicle storage and movement areas within the building. There is no physical separation between these two functions and staff members commingle with vehicles moving in and out of the facility several times a day.

The vehicle storage bays of the building are completely full and stored vehicles commingle in spaces with other functions like the sign shop, maintenance shop and wash bay. When the wash bay needs to be utilized fleet vehicles need to be removed from the wash bay and parked outside the building.

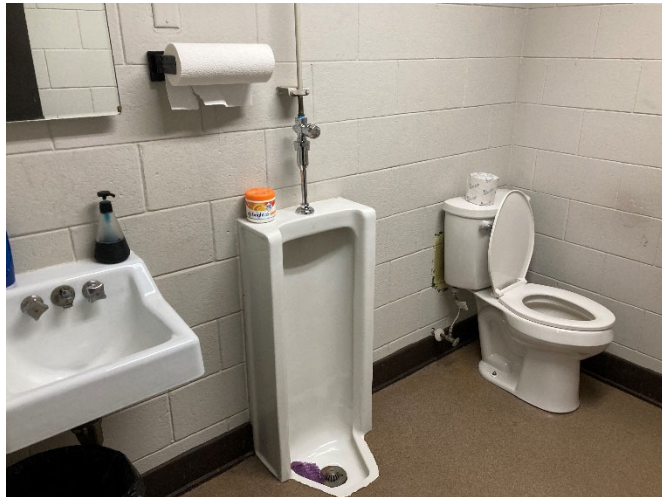
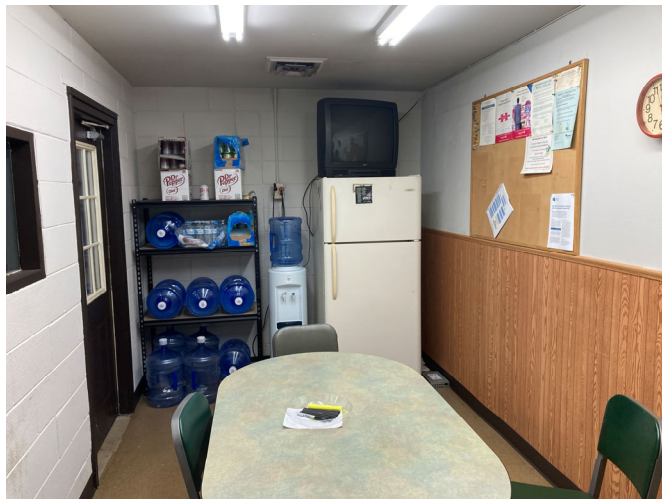
There are small non ADA accessible toilet rooms directly off the shop. These restrooms typically serve the DPW staff and are an additional convenience for on duty officers from the Sheriff's Department. There is a small break room adjacent to the DPW vehicle storage garage. It is technically reserved for DPW staff but during the interview process it was relayed to the consultant that the break room is too small to occupy by all on shift DPW staff. To accommodate for this staff takes their breakout in the

The existing overhead doors were original to the building and were not modified during the 2004 renovation. The are too small to accommodate some of the newer plow trucks when they are outfitted with front plows and wings. Damage was observed on several of the door jams of the overhead doors, evidence that plow drivers are challenged with the width of the doors when their plow trucks are set up for plowing operations.

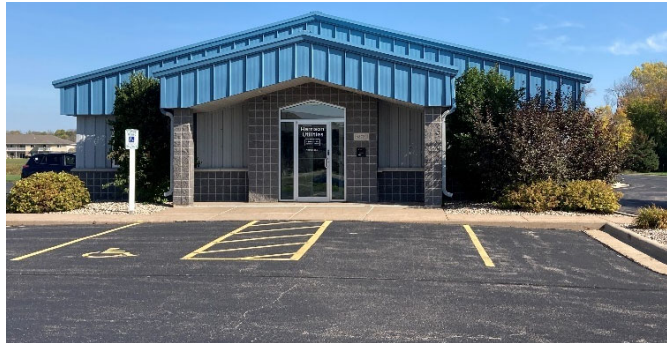
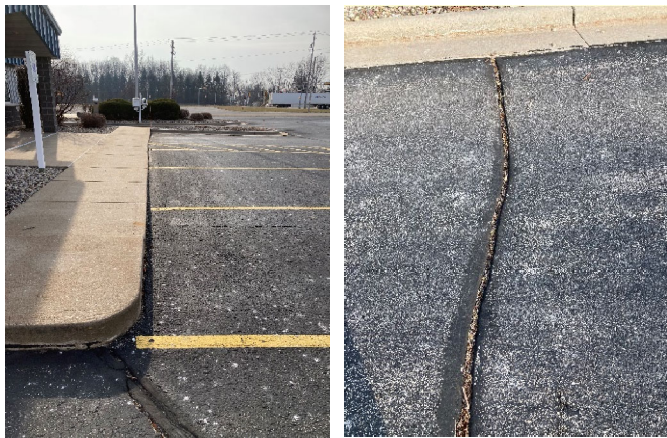
The parking lot contains concrete curbs and gutter around the South and West side of the building. Other areas of asphalt pavement are shouldered where they abut manicured lawn areas. Sheet drainage by sloping of the asphalt conveys stormwater away from the building. The asphalt parking lots have been seal coated and crack filled and are in fair condition.

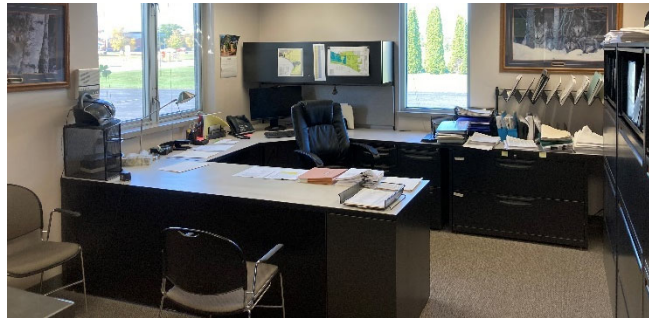
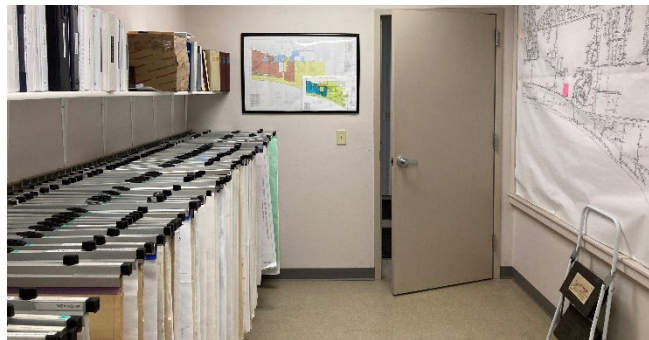
The interior of the building is in good condition and requires very little maintenance. The staff kitchenette and break area lacks ADA accessible countertop heights and there is not a work surface directly adjacent to the residential oven/stove. All of the case goods and cabinetry are in good condition. The microwave shelf above the stove top is not ADA accessible.

Office and storage areas appear to be adequately sized for the operation. In conversations, staff did not reveal the need for additional storage or work areas.

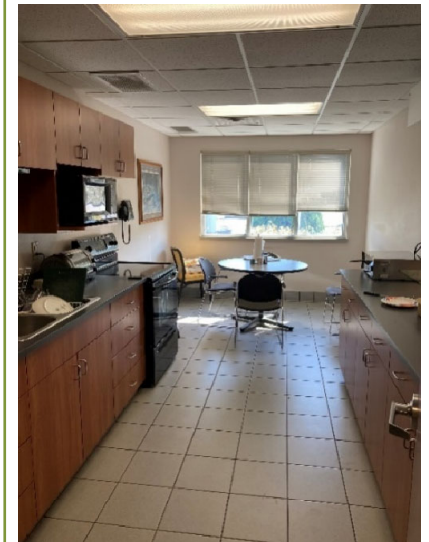
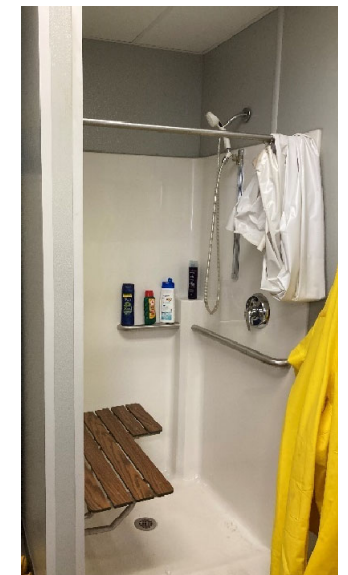
The toilet rooms are ADA accessible and only lack the 18 inch vertical grab bar required on the side of the water closet. There are some storage cabinets and furniture placed in the restrooms that were installed after occupancy. These additional accessory pieces are not ADA accessible. There is a staff shower that water department field staff utilize that appears to be ADA accessible.

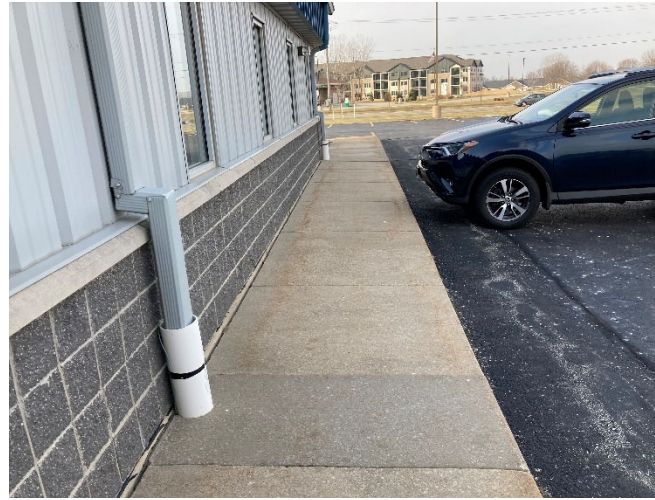
There was noticeable frost heaving of the approach slabs at the entrance doors. Over time, portions of the concrete was ground down to provide better accessibility to the entrances and eliminate trip hazards around the building.

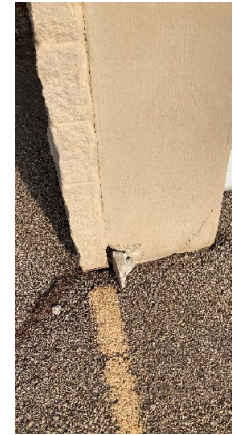
The exterior of Station 60 is in fair condition with the exception of some deteriorating masonry between the overhead truck Bay doors. Concrete masonry was used on most of the surfaces exposed to maintenance and potential abuse. Metal wall panels are installed 4 foot above grade on the north and West elevations of the building. The decorative concrete block is in fair to good condition and only require some surface staining removal.

The gutter system along the north elevation requires some repair to fix leaking spots along the entire run of the pre-finished metal gutter system. Downspout leader should be added in locations where the downspouts daylight to the

Clean the stained exterior masonry, properly seal the surface of the exposed split faced block

Repair the gutter on the North building eave and provide downspout extensions.

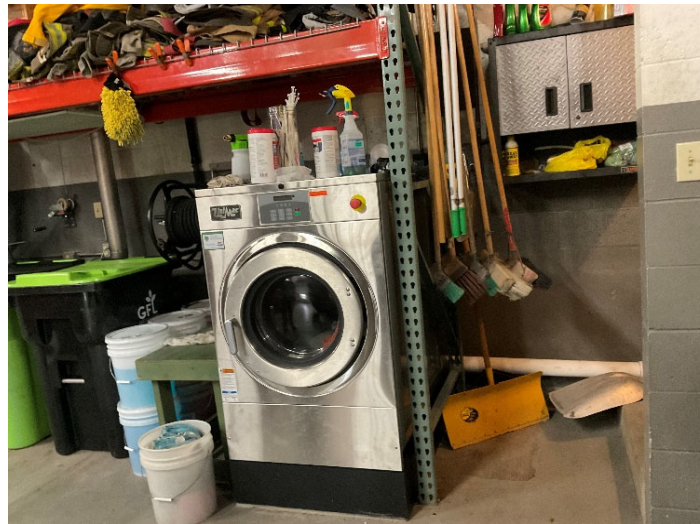
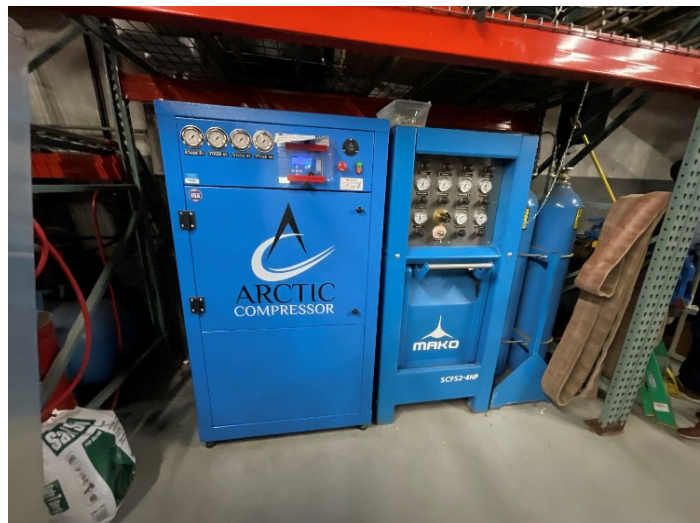
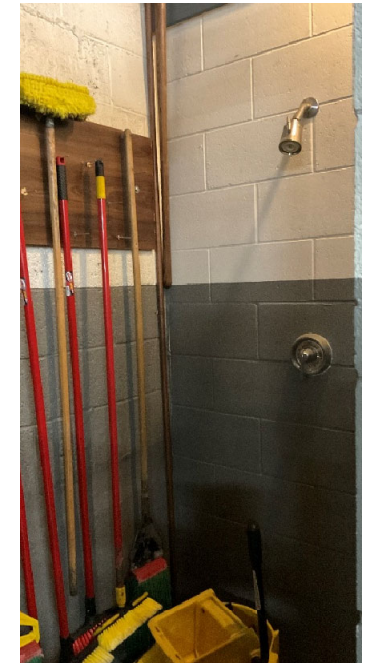
The interior configuration of Station 60 should be modified to include best practices for the health safety and welfare of the firefighters. Currently all of the maintenance operations ie. Air pack filling, bunker gear laundering, and turn out gear storage all take place in the apparatus bay where they are exposed to the harmful effects of carcinogens from vehicle exhaust. The decontamination shower is part of the apparatus Bay and should have its own separate showering and changing facility that is more conducive to the gender mix between male and female firefighters.

The toilet room should have better isolation from the apparatus Bay and exposure to vehicle exhaust. There are a few ADA improvements that need to be added to enhance the accessibility of the restroom.

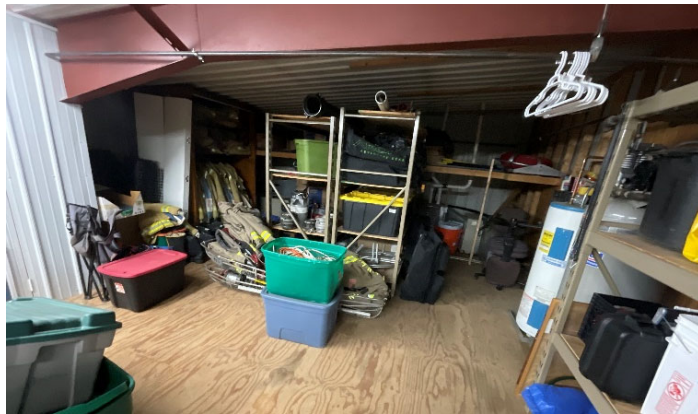
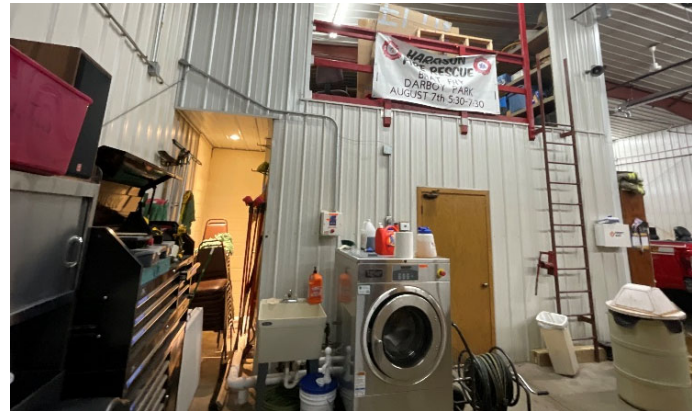
This creates some inefficiencies in terms of limiting access to the stored items when they are needed to be retrieved. It also impacts the amount of available storage space the Utility has at its disposal to store their own items. There is a mezzanine area above the administrative offices in Station 70 that houses the breathing air compressor as well as miscellaneous mass casualty items and spare gear. Based

on the construction type, the load limits of this mezzanine limit the ability to store any items of considerable weight.

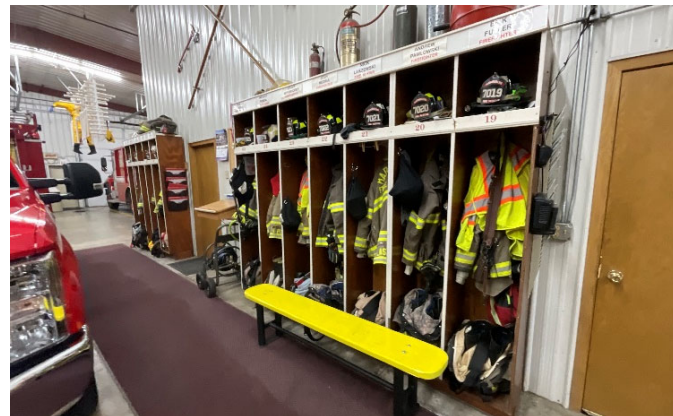
Station 70 faces the same health and safety issues that are present at Station 60. Administrative and maintenance functions like gear laundering, air pack filling, and general maintenance duties are done in the apparatus Bay. Station 70 does not contain a localized exhaust capture system typically found in fire stations. The lack of proper vehicle exhaust exposes staff and fire gear to toxins and carcinogens released from the apparatus while idling in the station.

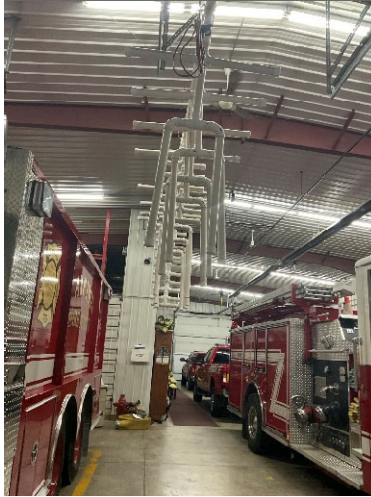
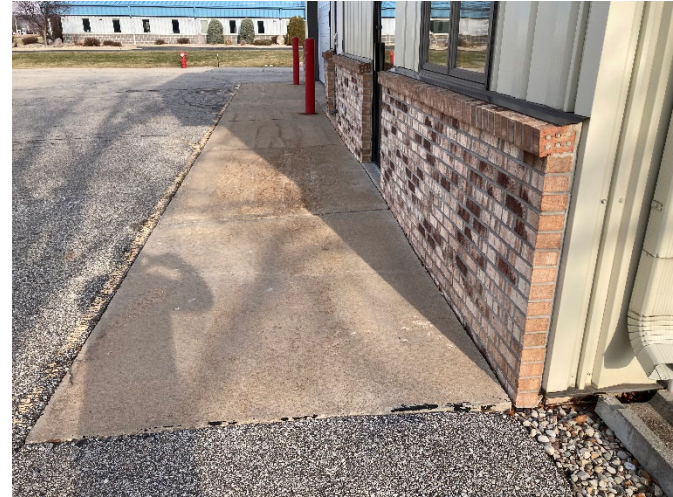
There is also a considerable safety concern for the firefighters who are donning their PPE directly adjacent to the truck floor while there is movement of emergency services vehicles. A safety zone between the truck floor and the turnout area should be provided to keep firefighters safe while preparing for deployment. Wet turnout gear is dried in the apparatus bay using makeshift PVC gear dryers. A floor mounted fan circulates air around the gear. This practice extends the drying time of the turnout gear which can be problematic during big fire events or multiple fire calls in succession.

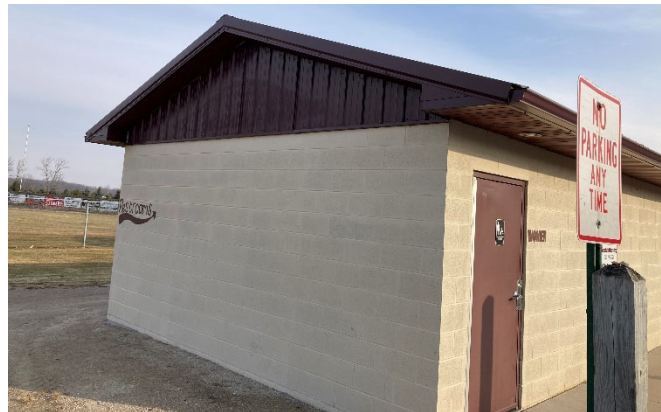
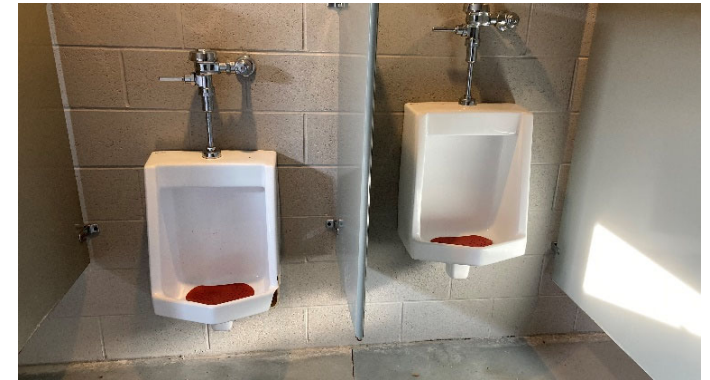
are covered with ribbed metal siding which appears to be in good condition.

The condition of the restroom is in good condition with the exception of one of the urinals in the men's toilet room that sustained some damage due to vandalism. There are vented aluminum soffits, gutters and downspouts all of which appear to be in good shape. The downspout extensions have sustained some damage and should be replaced.

Due to the current condition of the toilet room building it is recommended that the interior floors be epoxy coated, minor wall patching and painting where the soap dispenser was relocated and sealing the wood protection bollards are all preventative maintenance practices that will extend the life of the toilet room facility. Replacement of the vitreous china urinal in the Men's toilet room is also advisable.

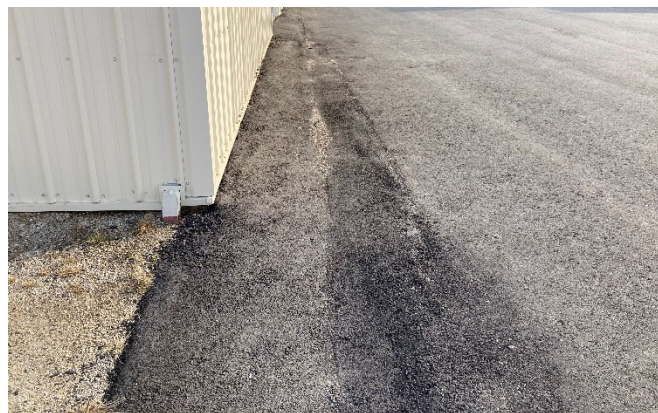
There are three walk up concession windows that are all mounted at Non-ADA height. The height of these concession windows varies from 3'-6" to 4'-3". ADA Accessibility requires the counters to be no higher than 34 inches above the finished floor.

The exterior walls of the concession building under the roof overhang are constructed of T-111 wood siding. The paint finish on this wood siding is showing signs of wear and should be repainted to minimize any water penetration into the wood. The roof structure is supported by 6"x6" treated wood columns that are attached by angle brackets to the concrete slab of the pavilion. The underside of the pavilion is sheathed with sheets of OSB plywood that is showing signs of deterioration. The entire ceiling surface of the pavilion should be recoated. There are surface mounted light fixtures that illuminate the pavilion. The fixtures appeared to be in fair condition. Power was cut to the building for the winter months so confirmation of the operation of these surface mounted light fixtures could not be verified.

Based on the age of the facility the requirements for ADA accessibility were not imposed when the building was constructed. In order to have the building comply to modern accessibility requirements the entire serving area would need to be reconstructed to lower the current step up condition as well as lowering the walk up windows. In order for these modifications to be made to bring the pavilion into compliance, it is likely more reasonable to completely remove the pavilion and reconstruct it to meet the accessibility requirements.

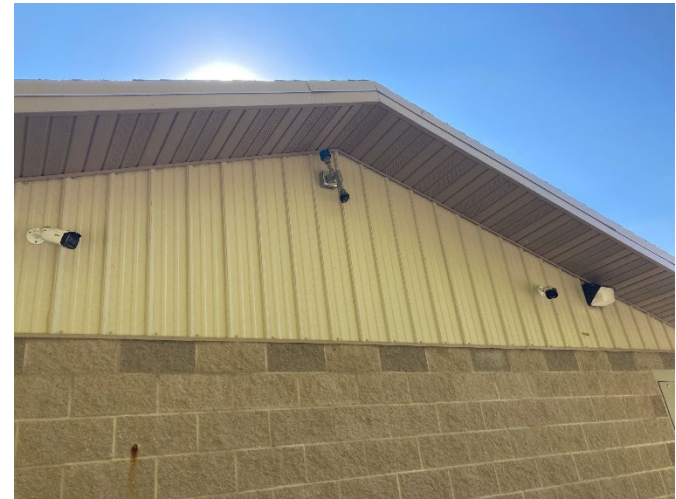
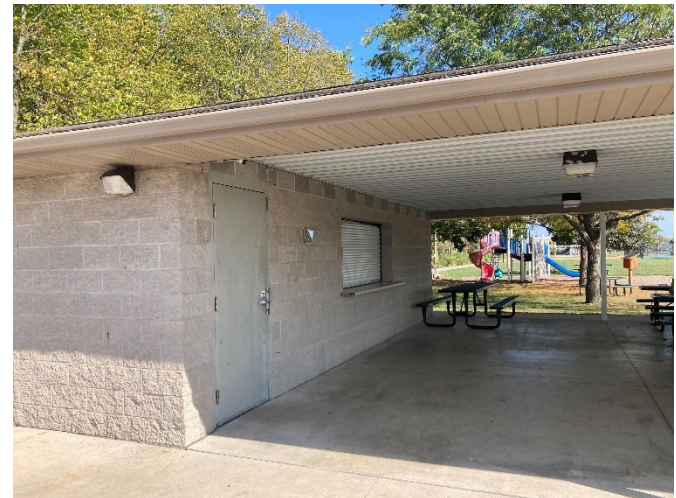
Continuous ridge vents provide proper attic venting but it was noted that some of the ridge cap asphalt shingles were missing and needed to be replaced. See the roof condition report provided by STR SEG, the forensic engineering consultant that is part of the appendix in this report. Pre-finished aluminum gutters and downspouts direct water away from the pavilion and appeared to be in fair shape.

ADA Accessibility: the open air park pavilion is not handicap accessible from the parking area. There is a 4-6" high curb along the side of the pavilion adjacent to the parking area that provides elevation transition from the parking area to the open air pavilion finished floor elevation. This curb prohibits ADA accessibility from the parking area. Accessibility concerns exist in the catering kitchen/ concession room in that the food preparation counter, the hand sink and the concession serving counter roll up window are not set at the appropriate height of

34 inches above floor elevation to meet the requirements of the ADA.

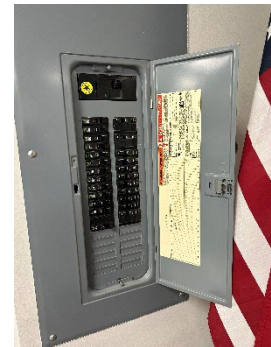
Main Electrical Service

- A. The main electric service is original to the 1998 addition. The service is 120/240 volt, 200 amp and is fed underground from a pole mounted utility transformer. The service is located in the first-floor meeting room. The service switchboard is a Square D QO Load Center type panelboard with a 200A main breaker. The panelboard is in good condition. No surge suppression device was found on the existing service.
- B. There is space for additional breakers in the existing distribution panelboard.
- C. The serving utility is WE Energies.

- A. The existing service panelboard is 25 years old and is nearing the end of its useful life and should be considered for replacement. Additional capacity on the electric service is available for small additions. However, if a large building addition were to be added to the facility, the existing service would likely need to be replaced with a new 120/208V service and switchboard with a surge suppression device.

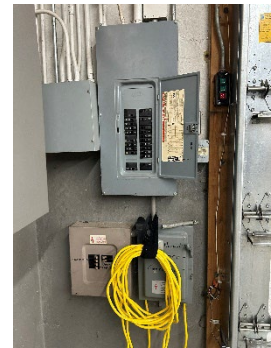
Existing Panelboard

- A. There are one Square D QO Load Center and two Cutler Hammer Safetybreaker Loadcenter type 120/240 volt panelboards in the building. These panelboards appear to be vintage to the 1998 renovation. These panelboards are in fair condition and have limited room for additional breakers.

- A. The panelboards should be considered for replacement based on their age. Provide new replacement panelboards and new feeders in existing conduit. If new loads are added to the facility, additional panelboards may be needed.

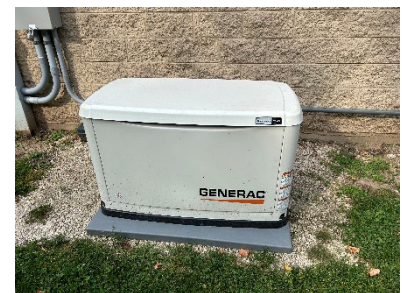
Existing Generator

- A. This facility has a natural gas, residential style, 26kW Generac generator. This generator back feeds the entire service via a 200A breaker switch located on the exterior wall adjacent to the utility meter. The generator was installed in 2023.

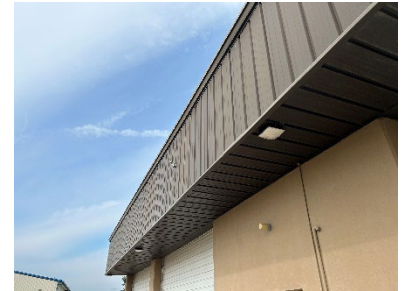
Existing LED Fixture & Photocell

- A. Most of the light fixtures throughout the facility have LED replacement tubes installed in the existing fixtures.
- B. Toggle switches are present for all lighting.
- C. No occupancy sensors are present in the facility.
- D. Exterior lighting is LED and are photocell controlled.

- A. Consider upgrading to all LED interior lighting with all new motion controls and dimmer switches.
- B. Consider upgrading to all LED exterior lighting with all new lighting control system.

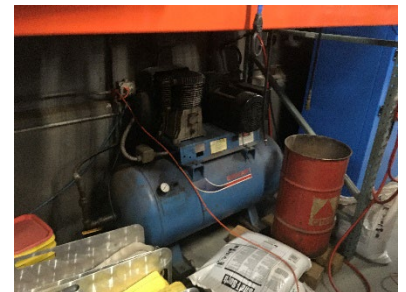
Air Compressor

- A. The system is served by 60 gallon 150psig air compressor which is piped to work stations, equipment and booths. The some of the pipe terminations has pressure regulators and filters. The system piping material is black iron steel. The isolations valves are ball valves. The air compressor is not capable of filling the truck tire pressure of 175psig. The overall system is in fair condition.

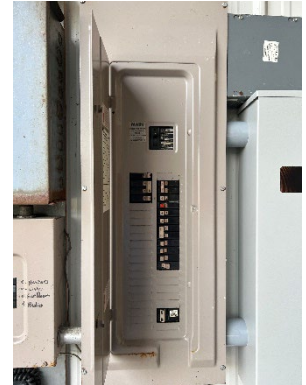
Main Electrical Service

- A. The main electric service is original to the facility. The service is 120/240 volt, 200 amp and is fed underground from the utility pad mounted transformer. The service is located in the first-floor vehicle garage. The service switchboard is a Cutler Hammer Safetybreaker Load Center type panelboard with a 200A main breaker. The panelboard is in fair condition with visible surface rust. No surge suppression device was found on the existing service.
- B. There is space for additional breakers in the existing distribution panelboard.
- C. The serving utility is WE Energies.

- A. The existing service panelboard is 30 years old and is nearing the end of its useful life and should be considered for replacement in new location to avoid corrosion. Additional capacity on the electric service is available for small additions. However, if a large building addition were to be added to the facility, the existing service would likely need to be replaced with a new 120/208V service and switchboard with a surge suppression device.

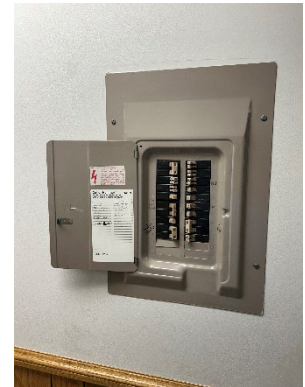
Existing Panelboard

- A. There are two additional Cutler Hammer Safetybreaker Loadcenter type 120/240 volt panelboards in the building. These panelboards are vintage to the original building. These panelboards are in fair condition and have limited room for additional breakers.

- A. The panelboards should be considered for replacement based on their age and one having several double breakers. Provide new replacement panelboards and new feeders in existing conduit. If new loads are added to the facility, additional panelboards may be needed.

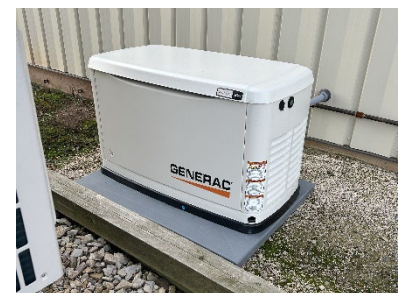
Existing Generator

- A. This facility has a natural gas, residential style, 26kW Generac generator. This generator back feeds the entire service via a 200A breaker switch. The generator was installed in 2023.

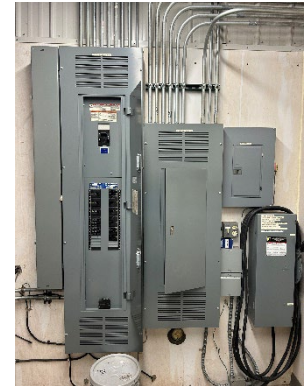
Main Electrical Service

- A. The main electric service is original to the facility. The service is 120/208 volt, 400 amp and is fed underground from the utility pad mounted transformer. The service is located in the first-floor electrical room. The service switchboard is a Square D NQOD type panelboard (double tub) with a 400A main breaker. The panelboard is vintage to the original building and is in good condition. No surge suppression device was found on the existing service.
- B. There is limited space for additional breakers in the existing distribution panelboard.
- C. The serving utility is WE Energies.

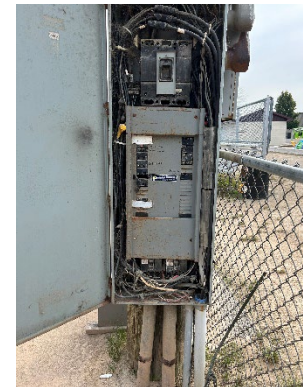
Main Electrical Service

- A. The main electric service appears to original to the facility. The service is 120/240 volt, 600 amp and is fed overhead from a pole mounted utility transformer and meter. The service is located in a NEMA rated exterior enclosure; pole mounted on the south side of the northwest softball field. The service switchboard is a Square D NQOB type panelboard with a 600A main breaker. The panelboard is in poor condition. When the enclosure door is open, there is no interior cover. This creates a dangerous situation with exposed cabling. Note: the enclosure was locked to prevent the public from accessing the panelboard. No surge suppression device was found on the existing service.
- B. The serving utility is WE Energies.

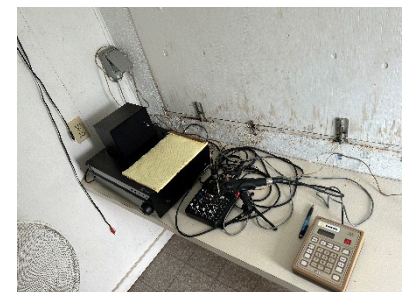
Existing PA System

- A. Each of the softball fields has a vintage dedicated PA system. The PA systems are in fair to poor condition. One of the horn speakers has fallen off the wall.

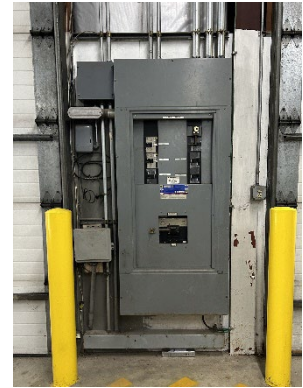
Main Electrical Service

- A. The main electric service is original to the facility. The service is 120/208 volt, 600 amp and is fed underground from the utility transformer and wall mounted C/T meter cabinet. The service is located in the first-floor public works vehicle garage. The service switchboard is a Square-D I-Line type panelboard with a 600A main breaker. No surge suppression device was found on the existing service.
- B. There is minimal space for additional breakers in the existing distribution panelboard.
- C. The serving utility is WE Energies.

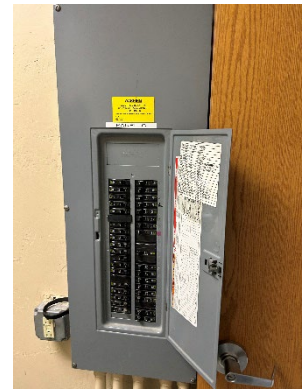
Existing Panelboard

- A. There are approximately three Square D QO Loadcenter type 120/208 volt panelboards in the building. These panelboards are vintage to the original building. These panels are in good condition but in general have limited room for additional breakers.

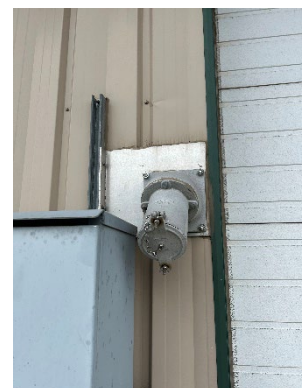
Mobile Generator Connection

- A. This facility does not have a generator. A mobile diesel generator is used in emergencies for limited loads. There is a mobile generator hook-up located on the exterior wall adjacent to the CT cabinet. This connection is made through a 250A breaker located in the distribution panelboard.

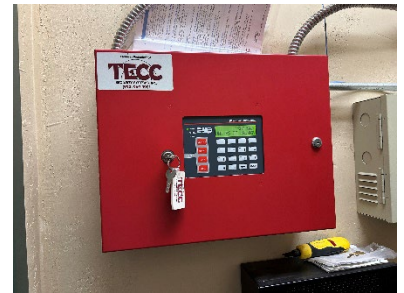
Existing FACP

- A. There is an existing DMP fire alarm system. The FACP located in the data closet appeared to be newer and in good condition.
- B. There were horn/stobes present and appeared to meet current code requirements.
- C. Manual pull stations were present.
- D. The fire alarm system is maintained and monitored by TECC Security Systems, INC., contact Eric at 920-969-9901.

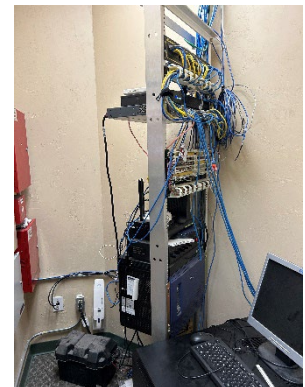
Existing Data Rack

- A. The floor mounted MDF data rack is located in the first-floor data closet located in the office area of building. The data service is provided by Spectrum and is coax cable type via Spectrum provided modem.
- B. The data cable is both CAT5E and CAT6 data cable which is routed to patch panels in the data rack.
- C. The building has wireless access points. There is also a cell signal booster located in the public works garage.
- D. The telephone system is VOIP.

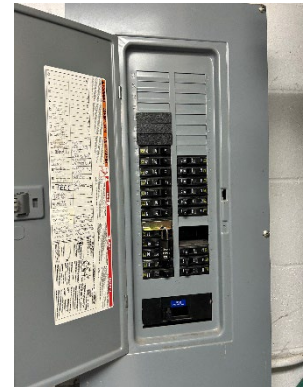
Main Electrical Service

- A. The main electric service is original to the facility. The service is 120/240 volt, 200 amp and is fed underground from a pad mounted utility transformer. The service switchboard is a Square D QO Load Center type panelboard with a 200A main breaker. The panelboard is in good condition.
- B. There is space for additional breakers.
- C. No surge suppression device was found on the service.
- D. There is an additional metered service at this facility serving two exterior mounted 200A, 240V disconnect switches mounted on backboard adjacent to the playground. This appears to be a service for providing power for outdoor entertainment.
- E. No surge suppression device was found on the service.
- F. The serving utility is WE Energies.

- A. Additional capacity on the electric service is available for small additions. However, if a large building addition were to be added to the facility, the existing service would need to be replaced with a new 120/208V service and switchboard with a surge suppression device.

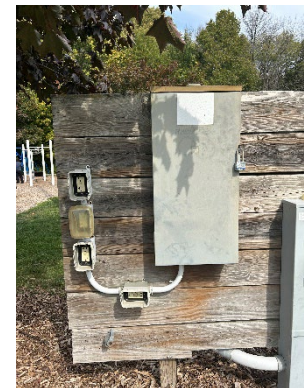
Missing Covers

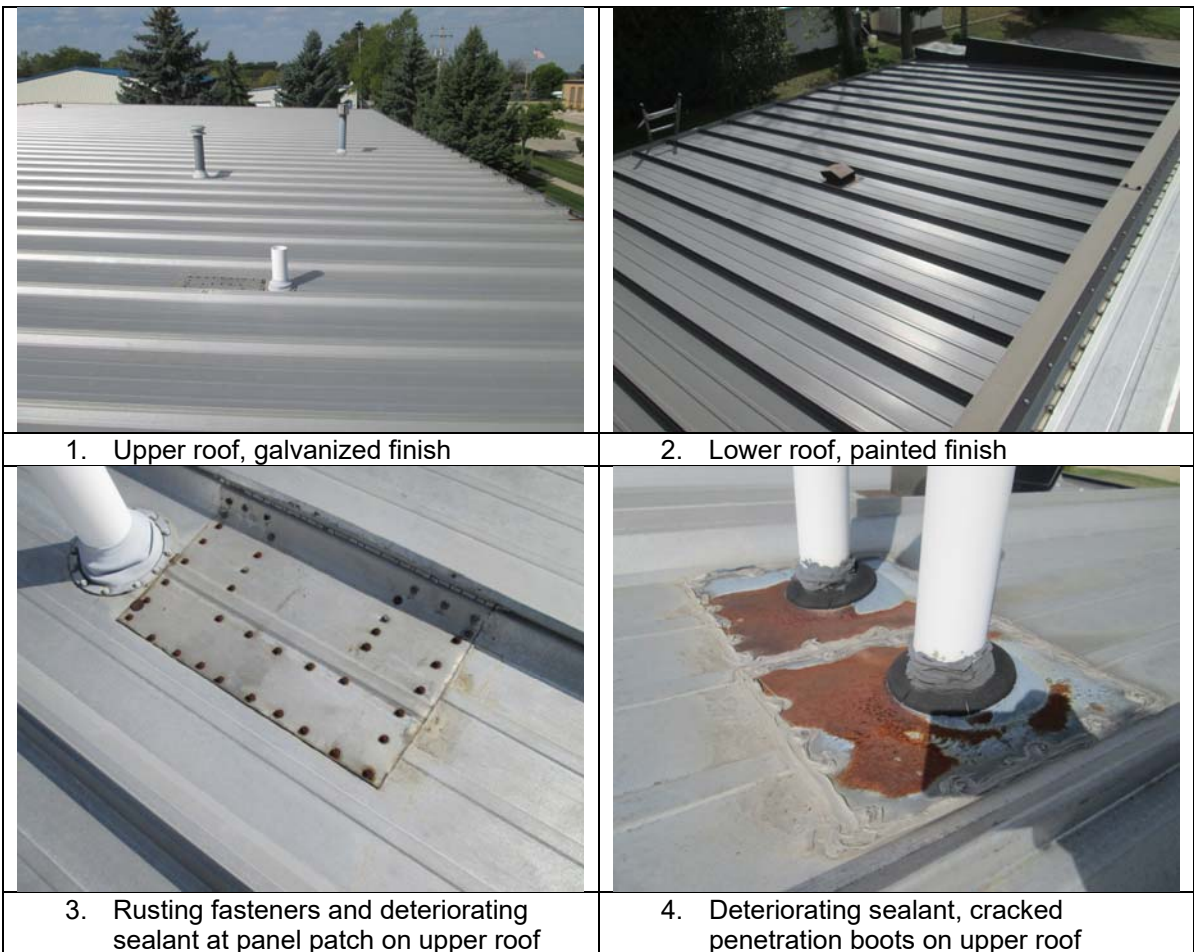
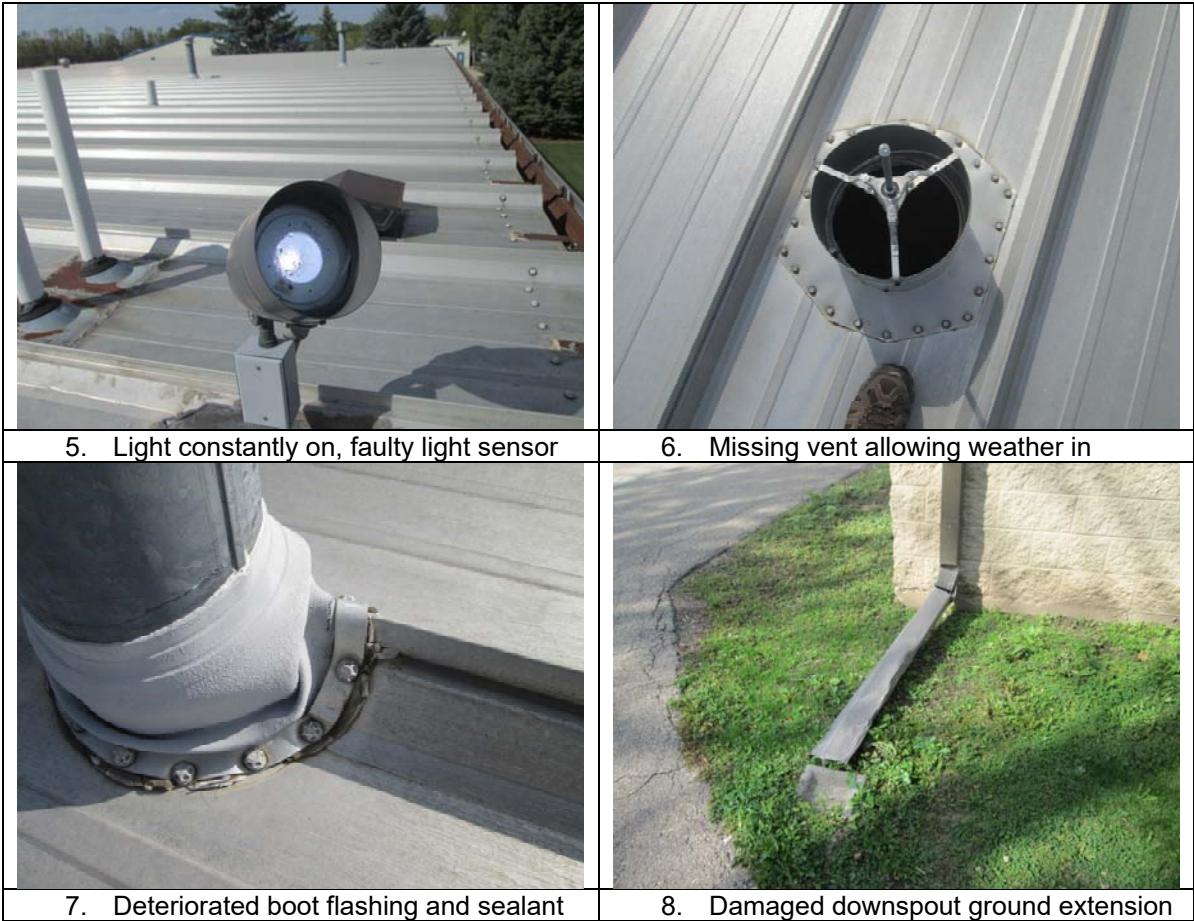
Fire Station 60 Building:

The roofs at this facility consist of two areas of structural standing seam metal panel roof systems. One section is pre-finished, the other is galvanized. The age of the roofs are unknown and appear to be original to the building. Drainage is via roof edge gutters and downspouts and appears to be satisfactory. In general, the panels appear to be in satisfactory condition with no panel damage or fastener back-out noted. Weathering of the sealant and splitting of boot flashings was noted which will require some maintenance to maintain watertightness. Periodic (2-3 year intervals) reviews to monitor conditions will also be necessary. A wind-driven vent stack on the upper roof is missing and allowing moisture from the exterior to enter. The roof mounted flag light was on, likely due to a faulty light sensor switch. The ground extension of the downspout on the southeast corner of the building is damaged.

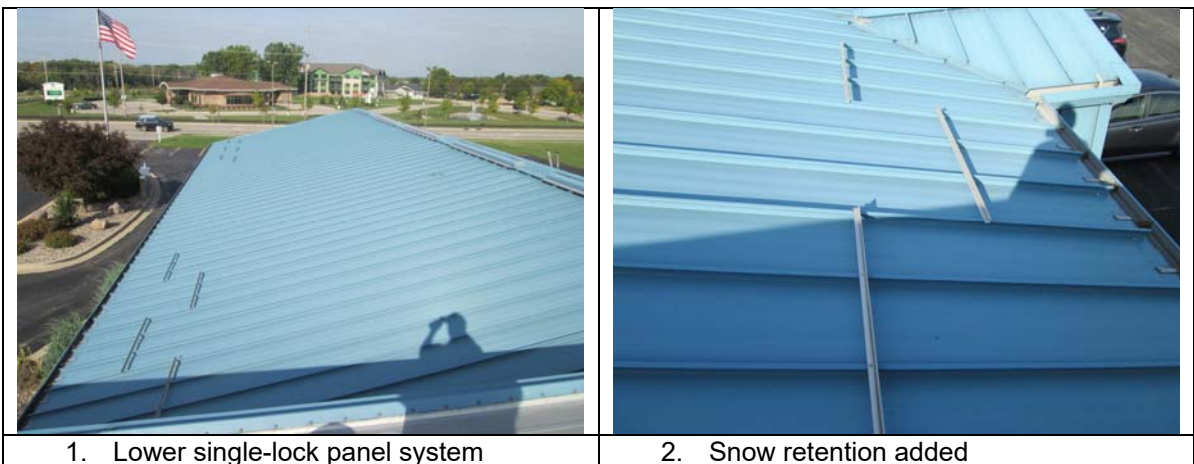
The roofs at this facility consist of three roof areas and two variations of metal panel roofing. The roof over the entrance and office area consists of a single-lock standing seam metal panel. The roof is original to the building constructed circa 2001. Drainage is via roof edge gutters and downspouts and appears to be satisfactory. The seaming of the panel was poorly performed and does not appear to be fully crimped. The seams do appear to have sealant applied which was folded into the seams along with the concealed clips which anchor the panel to the structure. No panel damage or fastener back-out was noted. Weathering of the sealant at penetrations was noted which will require periodic (2-3 year intervals) reviews to monitor conditions as the sealant weathers.

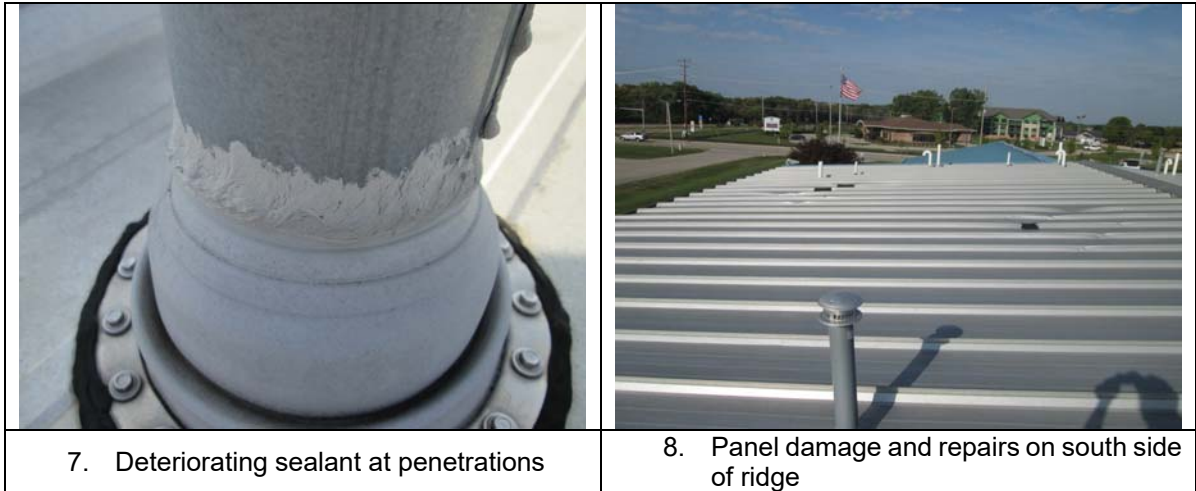
6. Panel repairs made with uncured EPDM and sealant

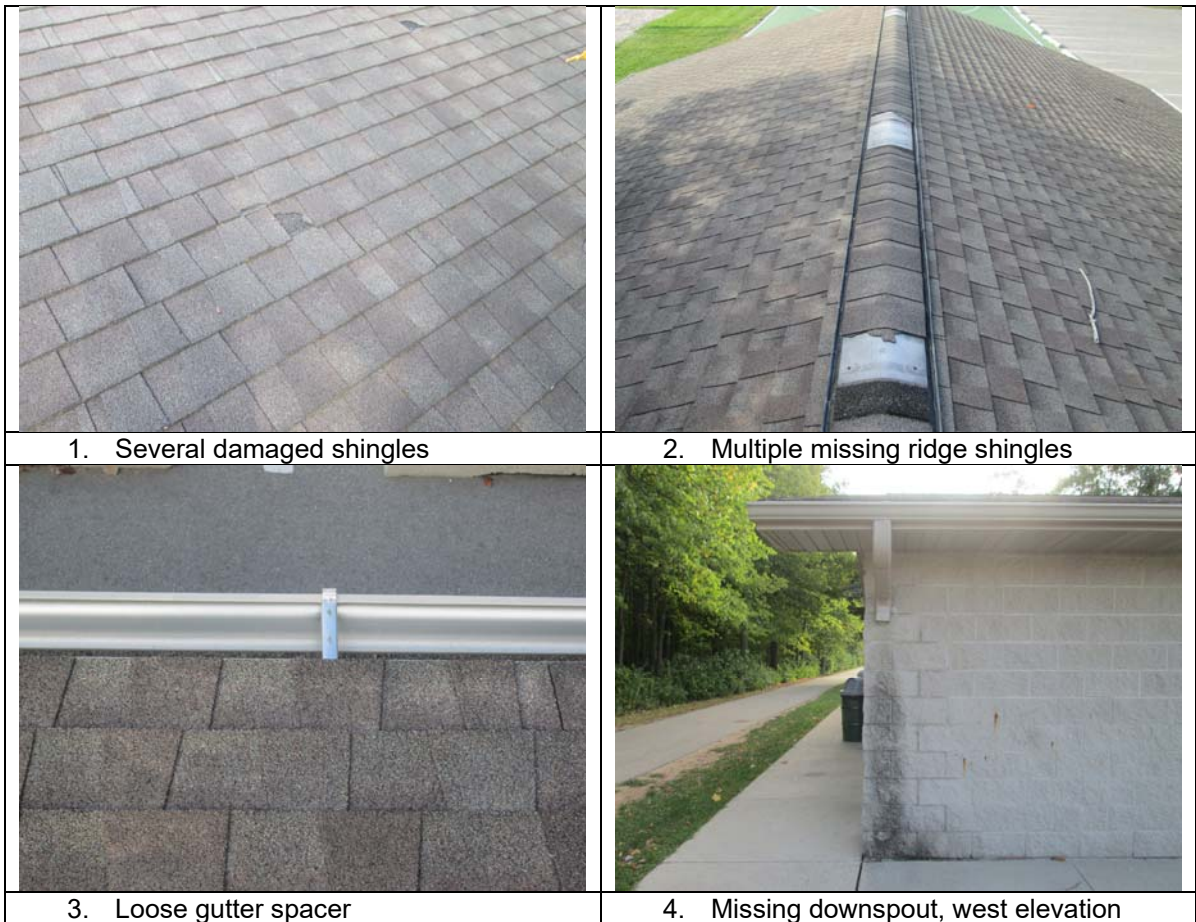
Darboy Community Park Pavilion:

The roof at this facility consists of an asphalt shingle roof system. Drainage is via roof edge gutters and downspouts and appears to be satisfactory. The age of the roof is unknown but appears to be in the 10 – 15 year range. Several missing and damaged shingles were noted, likely vandalized. Cracking of surface asphalt and granule loss throughout. Downspout missing on west elevation.

- Darboy Pavilion – Replacement in-kind; \$30,000 - \$35,000
 - HAA Pavilion – Replacement in-kind; \$35,000 - \$42,000
-

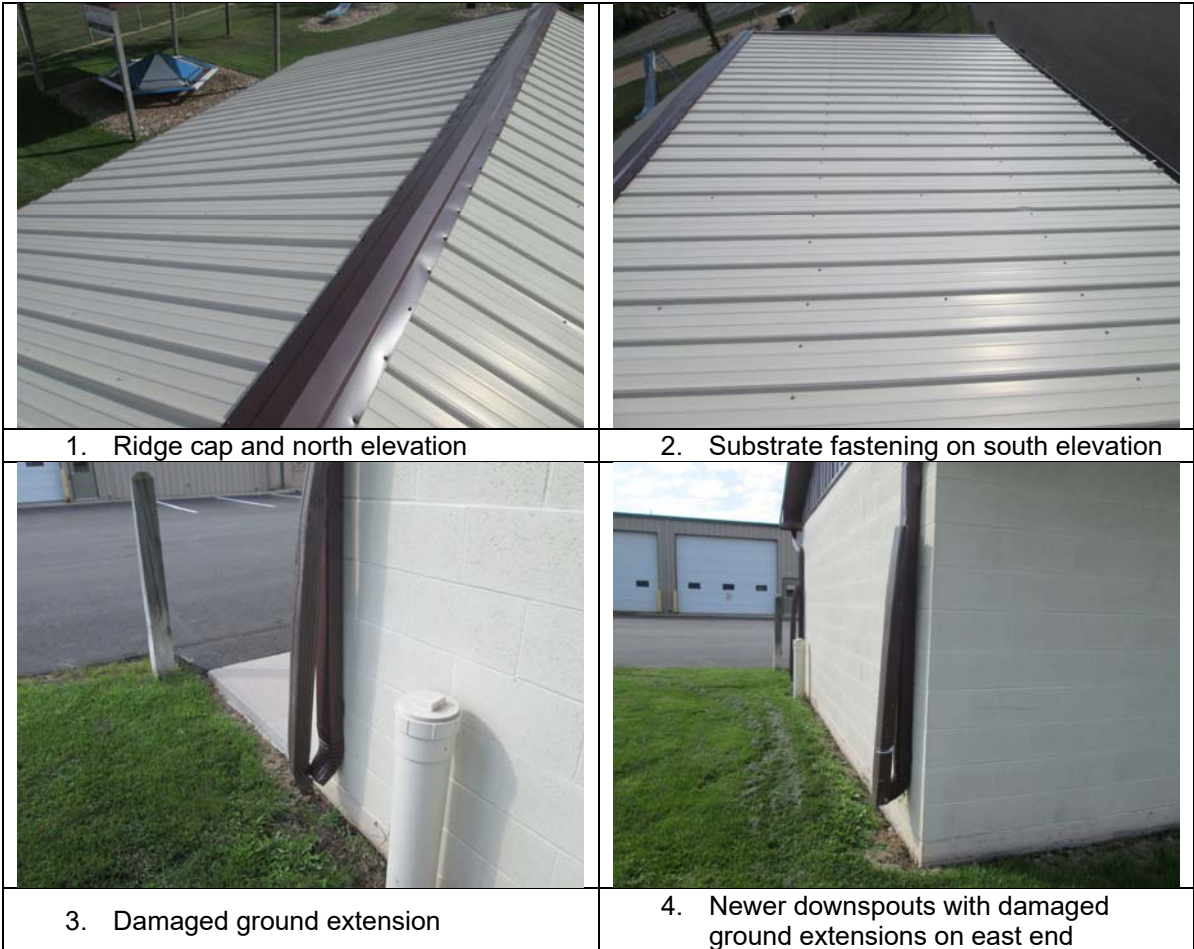
Harrison Athletic Association Park Restroom Building:

The roof at this facility consists of an exposed fastener metal panel roof system. Drainage is via roof edge gutters and downspouts. The age of the roof is unknown but appears to be newer. The downspout ground extensions have been damaged.
